**PUBLIC CONSULTATION PAPER
WIRELESS LOCAL AREA NETWORK (WLAN)
IN THE 6 GHz FREQUENCY BAND**

**Test Report on the Effects
of 6 GHz Unlicensed RLAN units on Fortson to Columbus
Microwave Link**

**Prepared in Partnership with
Southern Company Services**

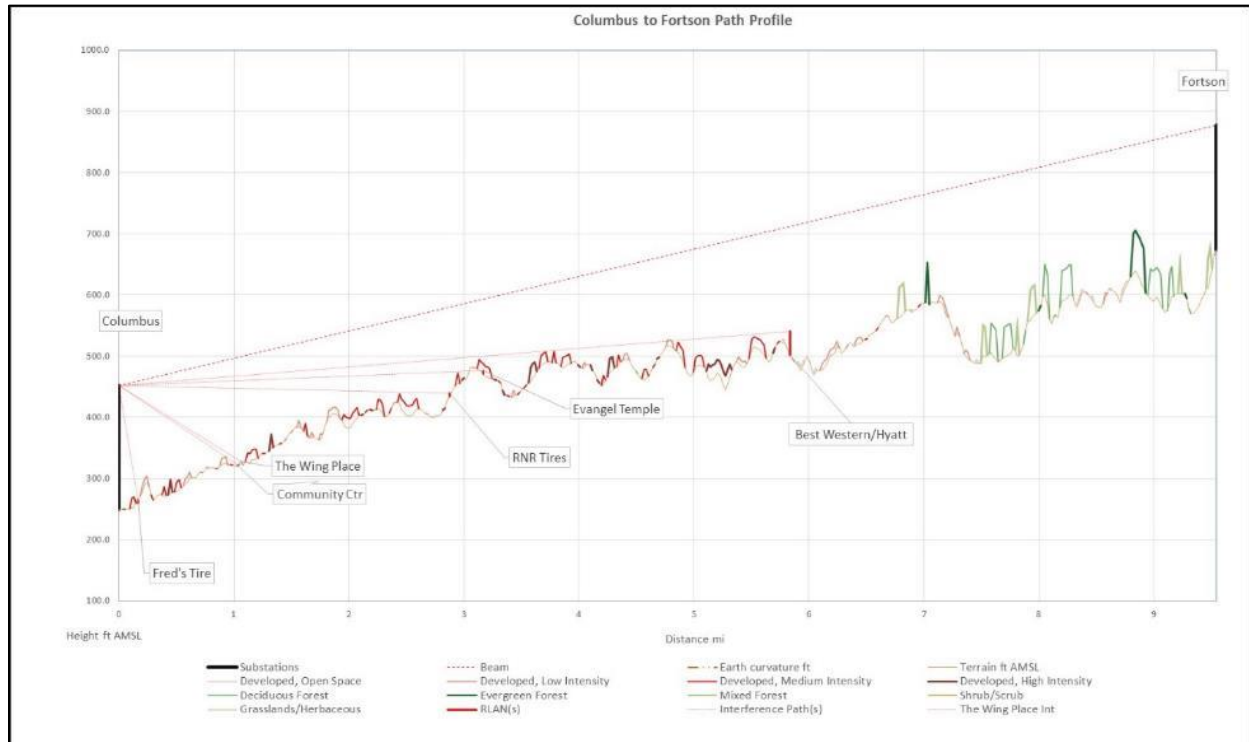
Interference strong enough to impact the licensed microwave Fixed Site (FS) from a Wi-Fi LPI device may be blocked by clutter in the line-of-sight between the LPI and the FS. This clutter can be terrain, buildings, or tall foliage (typically trees). There is no value in testing the impact from areas that are obstructed (clearly many locations in a typical main beam will be obstructed – the issue is those locations that are not obstructed creating interference), so a terrain profile was used to pick test locations that are both inside the main beam and appear to be unobstructed. That profile is shown below, along with 7 test locations picked before arrival in Columbus.

Figure 2: Fortson-Columbus Path Profile with Test Locations

Testing was conducted at seven locations, ranging from 285 meters from the fixed microwave receiver up to 9.4 kilometers. The table below provides details on each location.

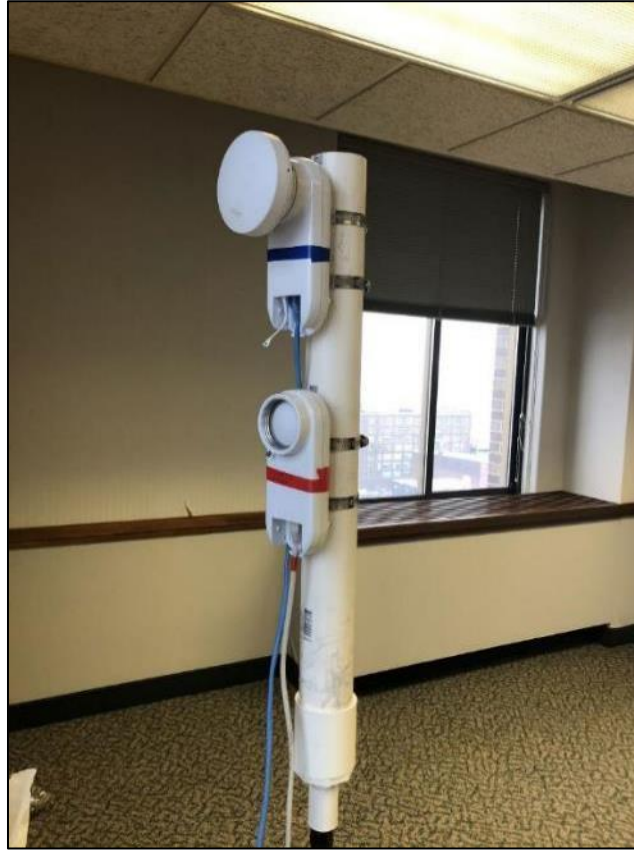
Mimosa equipment use in earlier tests indicate it causes interference to licensed paths sooner and more severely than RLAN equipment. This finding, combined with feedback from ex-parte discussions that more test locations would be favorable, has resulted in modification of test plans as documented below. Mimosa equipment was used to test locations for impact before the RLAN equipment was unloaded and turned up. If the Mimosa equipment did not produce impact to the licensed link, no further testing of the location was made based on the assumption there is some obstruction to the path from that test location to the FS receive site (terrain, buildings, foliage, etc.). If the Mimosa equipment does impact the link, the remainder of the testing was performed and results documented.

Figure 12: Mimosa C5x Setup Visual

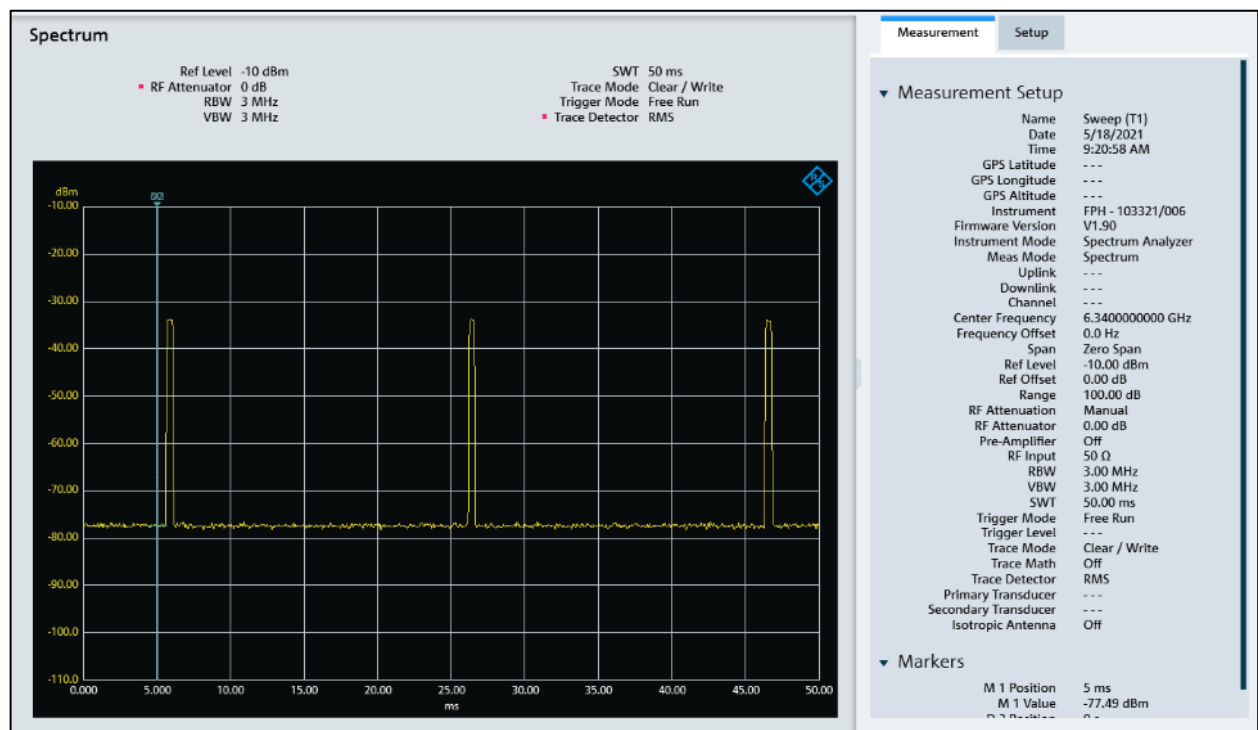
- Given the numbers above, the *minimum duty cycle* for a 6 GHz AP with no data is $.464/20.5$ or **2.2%**. This is far in excess of the 0.4% cited by the Commission in the rulemaking decision or the 0.00022% used in the proponent's Monte Carlo analyses for 90% of the RLAN APs or the 0.11%, 0.22%, and 0.44% used for the remaining 10% of RLAN APs (all duty cycles used in their analysis clearly ignoring the effect of beacon transmissions).⁴ It should come as no surprise that the beacons alone demonstrated impact to the licensed microwave link in testing.

Figure 14: Time Domain view of Beacons

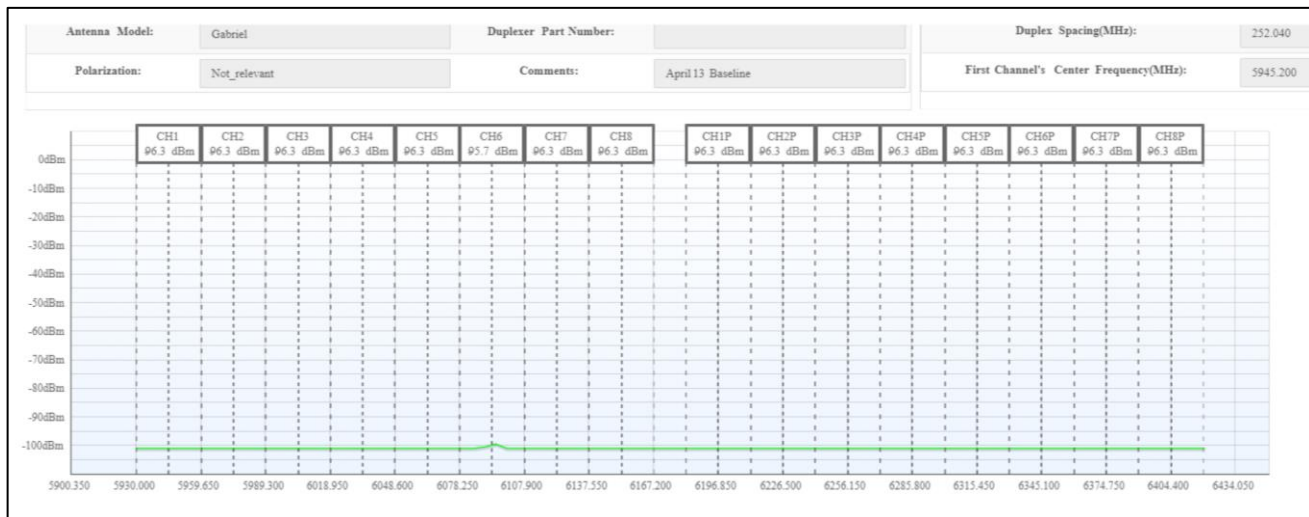
The next step in the process was to observe received signal at Columbus both with and without transmit operation at Fortson to determine spectrum occupancy and levels in normal operation and any pre-existing interference. None was found as shown in the pictures below. The small signal around 6093 MHz is most likely a reflection of the Columbus transmitter since it is on the Columbus transmit channel. The scans follow measured levels reasonably closely (Fortson RSL at -36.3 dBm, noise at -99 dBm [thermal], -96.5 dBm [with receiver noise figure of 2.5 dB]).

Figure 22: Columbus Wavence Receiver Scan with Fortson transmitter off

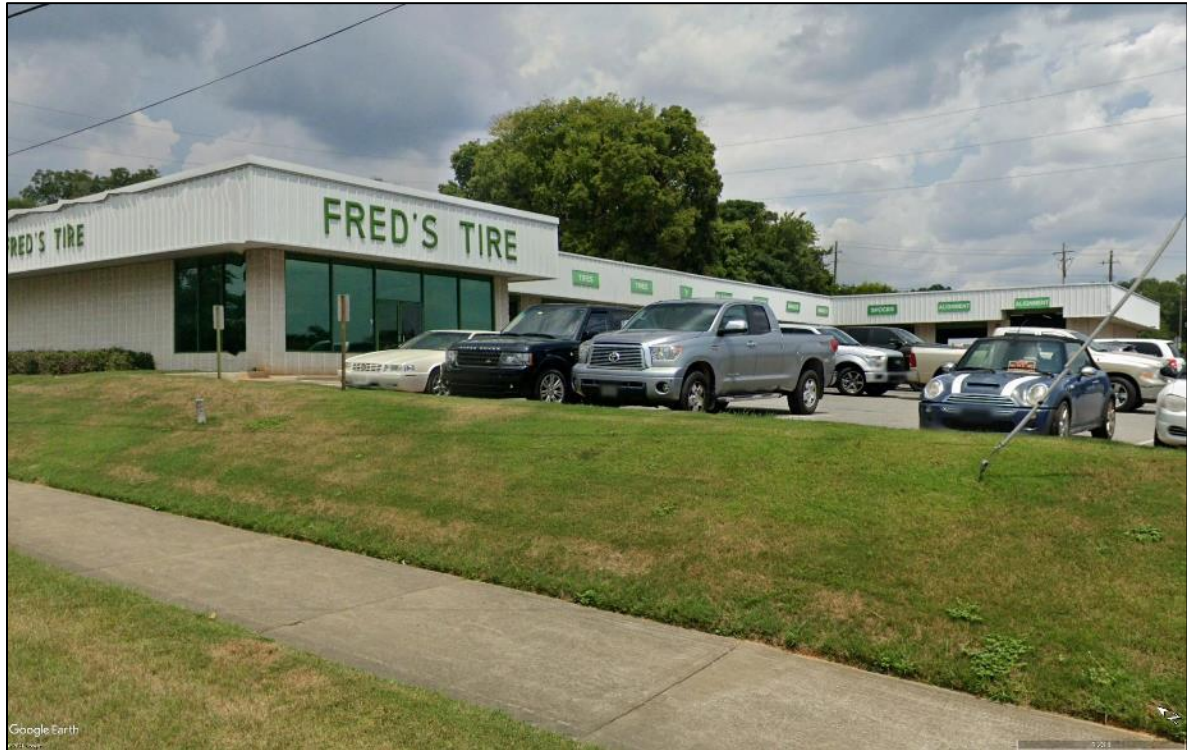
Figure 29: Fred's Tire view from 2nd Avenue

Fred's Tire as viewed from 2nd Avenue is shown below. The second window from the corner in the front was used for the "in window" test location. The doors in the middle of the nearer portion of the building are across from the counter used as "on counter" test location. And the far corner where the service bay section turns to the south, under the green "Shocks" sign, is the area used for the "Service bay" test locations. Also note the reflective film on the windows discussed below.

It was noticed that the reflective film was missing on one of the two doors so a test was performed with the Asus on the counter, 4 meters inside the door with line-of-site to tower through clear pane. Results were 6.4 dB impact with beacons plus data, the beacons only test was inadvertently omitted as was a photograph of that arrangement. The AP was then moved straight down to the floor in front of the counter with a clear Line-of-Sight to the tower and results were 2.0 dB impact with beacons only, 14.2 dB impact with data.

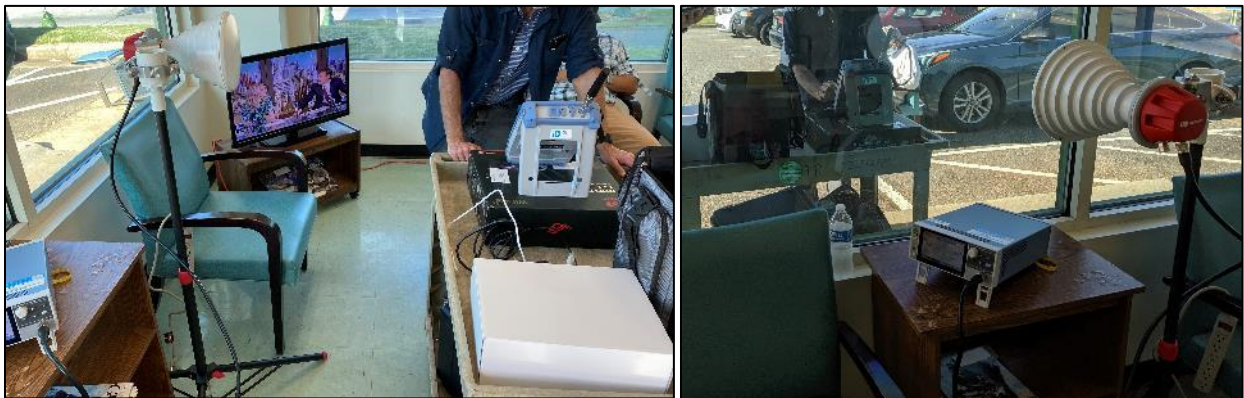
Curious about the building entry loss given the criticism of window locations previously, loss through the window was measured by using a vector signal generator (which was calibrated) at Columbus center frequency (6345 MHz) into a directional antenna and measuring the field strength with a spectrum analyzer 1 meter from the antenna both inside and outside the building with the antenna rotated 180 degrees between measurements. The difference between the two measurements was - 22.0 dBm inside versus -43.1 dBm outside or 21.1 dB Building Entry Loss (BEL). Notably this BEL exceeded the number cited in the FCC R&O footnote 297 (20.5 dB) by 0.6 dB.

Figure 31: BEL Test setup at Fred's Tire

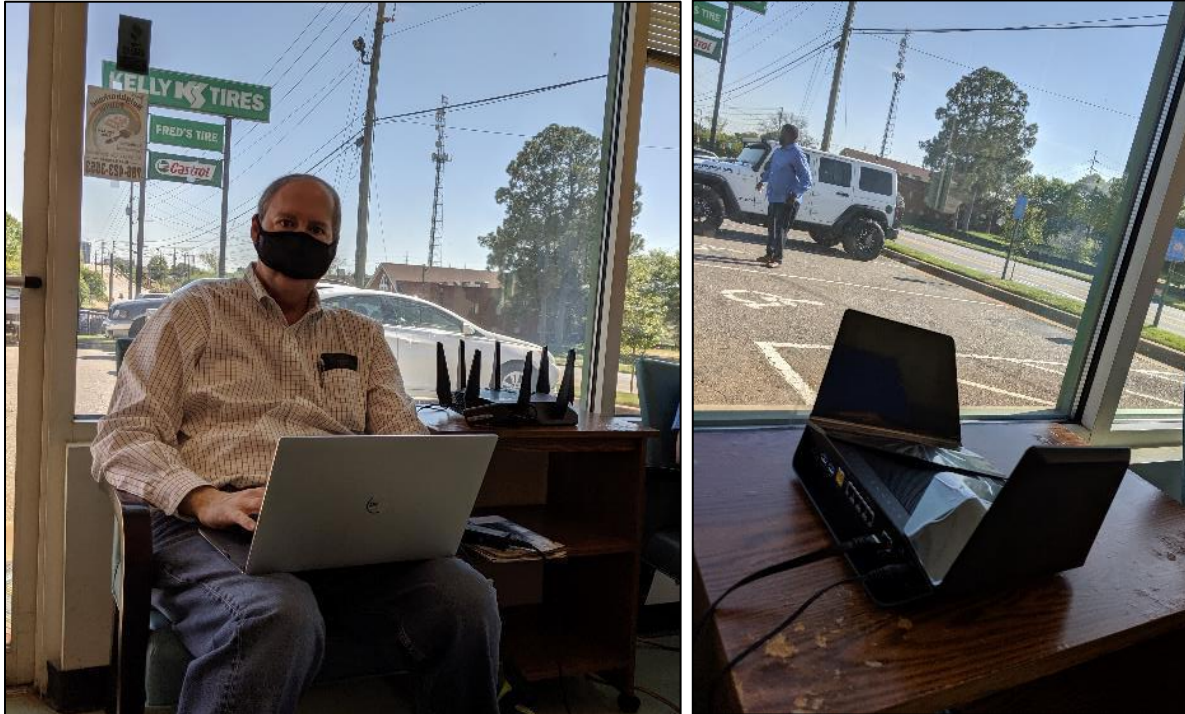
Initial testing at Fred's was with the AP in the second window over from the west corner of their waiting room, sitting on a magazine table already in the window. Given it was the first testing with a commercial off the shelf AP, many different settings were tried and the impact of changes recorded. Notably a 1.2 dB of fade margin impact was measured with beacons only on channel 77 (15 MHz bandwidth overlap as noted previously) on both Asus and Netgear routers. With low speed data the fade margin impact increased to 3.1 dB with Asus but somewhat less, 2.7 dB with Netgear. High speed data increased the impact by approximately a dB so going forward the focus on repeating measurements was dropped to save time but it was noted if the testing was with Samsung (low data rate) or laptop (high data rate).

Beacon only impact was tested with the Asus setup screen set to 50 millisecond beacon spacing, 100 msec (default), and 200 msec and noted identical impacts – a bit puzzling at the time but later explained when it was found in post testing that the beacons repeated at 20 msec rate regardless of the setup parameter value on both Asus and Netgear APs.

Figure 32: Fred's Tire "in window" test location

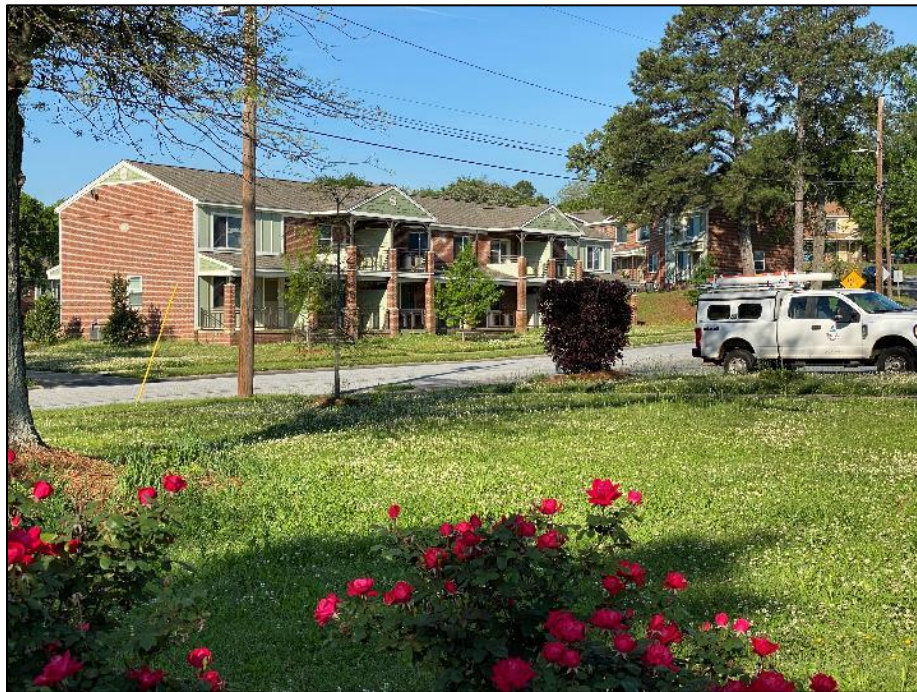
Figure 38: View from Community Center towards FS

Investigation revealed what appeared to be a Community Center on Google Earth and it looked good as a test location. Southern’s local personnel made contact, found it was a housing management office for the complex with common areas, and arranged for us to visit. Upon arrival, preliminary testing found the area was obstructed by buildings and foliage between the location and the Columbus FS tower, as well as the lay of the land appearing lower than expected from Google Earth – there was no visibility of the tower. No additional testing was performed here.

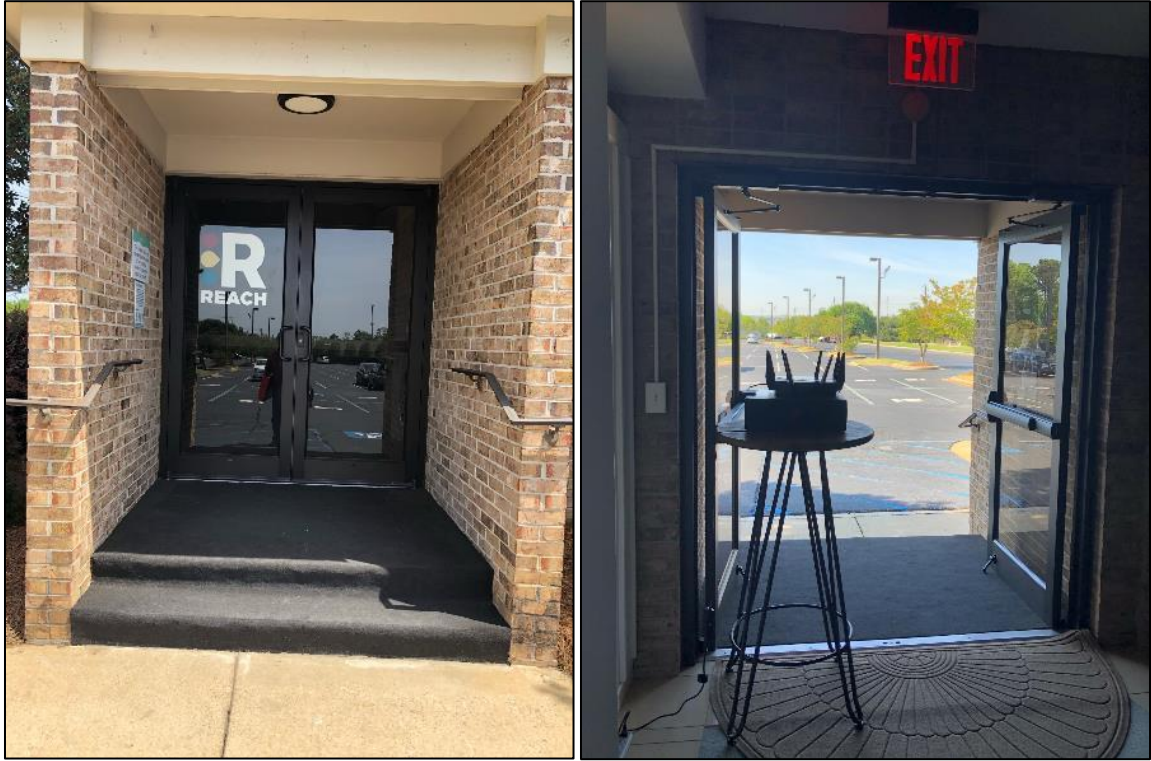
Figure 48: Evangel Temple entryway from outside and inside

Evangel temple has no clear view of the tower – it is hidden behind trees to the south of the complex. But preliminary testing showed impact to Columbus receive, so full testing was performed. The entryway used is the main entrance from their parking lot into the Temple, feeding the sanctuary on the right with multiple doors along the curved hall as well as the balcony level up the stairs on the left. Access points and boxes with ethernet stubs for new access points were noted in multiple places on the ceiling.

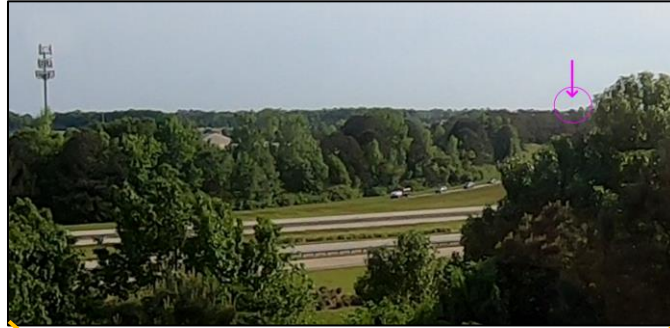
Hyatt room 503 was rented by a team member and initial investigation and preliminary testing were successful. Room 503 had a clear view of the Columbus FS tower with no clutter or foliage in the path. And the Mimosa C5 units resulted in approximately 1 dB of impact to fade margin so detailed testing was performed. With Asus AP on the bed near the window as shown below, beacons only, produced no impact to Columbus receiver. High speed data running resulted in 0.2 dB of impact to fade margin. This is a relatively small impact but the Hyatt has eight to ten rooms with a similar view of the site and that many more that have only local trees obstructing them and would be additive if more than one overlapped Columbus frequency.

Figure 52: Hyatt Test Location with Site Enlarged

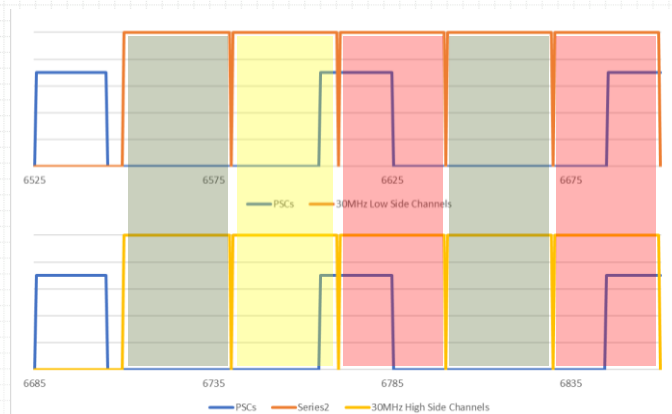
30MHz channels show 2 unimpacted, 1 slightly impacted, and 2 significantly impacted

Channel pair shading: Green=no overlap, Yellow=some overlap, Red=significant overlap
